# Anatomy of a shaft crack

When Hugh Stott, Steam Turbine Engineer for Public Service Electric and Gas (PSEG) received the report of high vibration on Unit No. 7 steam turbine generator at the Burlington, New Jersey power station, he knew the problem was serious.

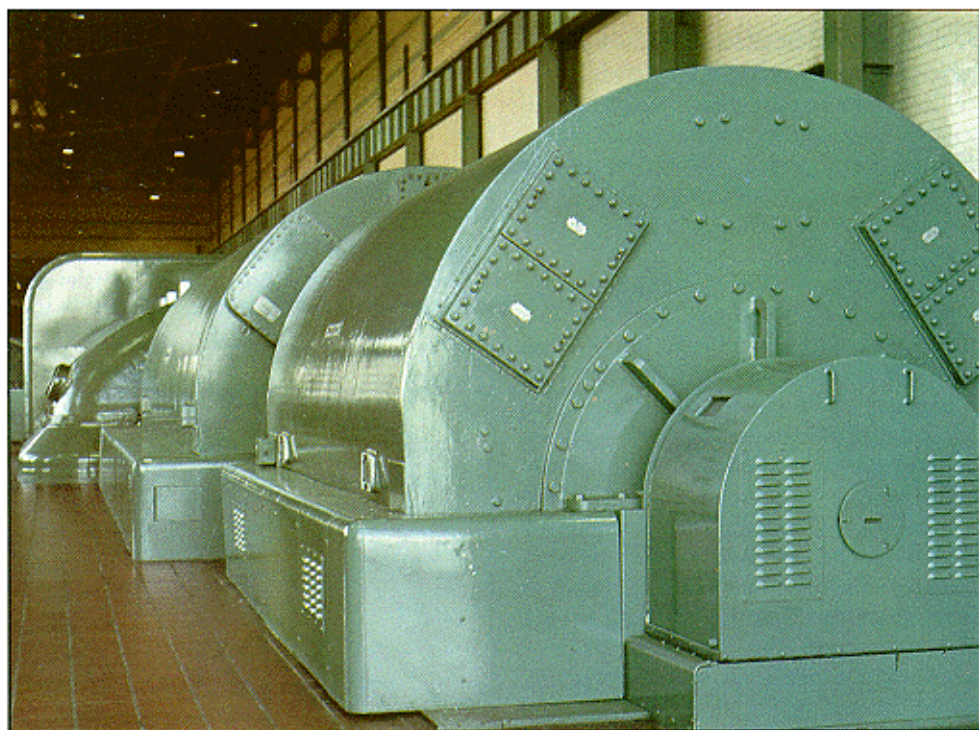
**The analytical methods used by PSEG enabled their engineers to properly diagnose the shaft crack on the 30-year-old steam turbine generator.**

The machine was not put back in service, but opened and inspected. Inspection revealed a crack 400 degrees around the circumference with a 270-degree penetration to the bore in the double flow low pressure rotor at the generator end in the wheel-to-shaft radius.

This disciplined approach aided Stott in making a sound decision to shut down the machine prior to catastrophic damage being incurred. After major repairs to the LPDF rotor, Burlington's Unit No. 7 was returned to service in June 1985. The rotor was repaired by cutting off the rotor between the generator end L-0 and L-1 stages, welding on a new forging, machining it to original dimensions, and reassembling the L-0 blades. The rotor is running well with low levels of vibration.
